# Vertical Root Fracture Findings from Cone Beam Computerized Tomography: A Serial Case Analysis

## Abstract

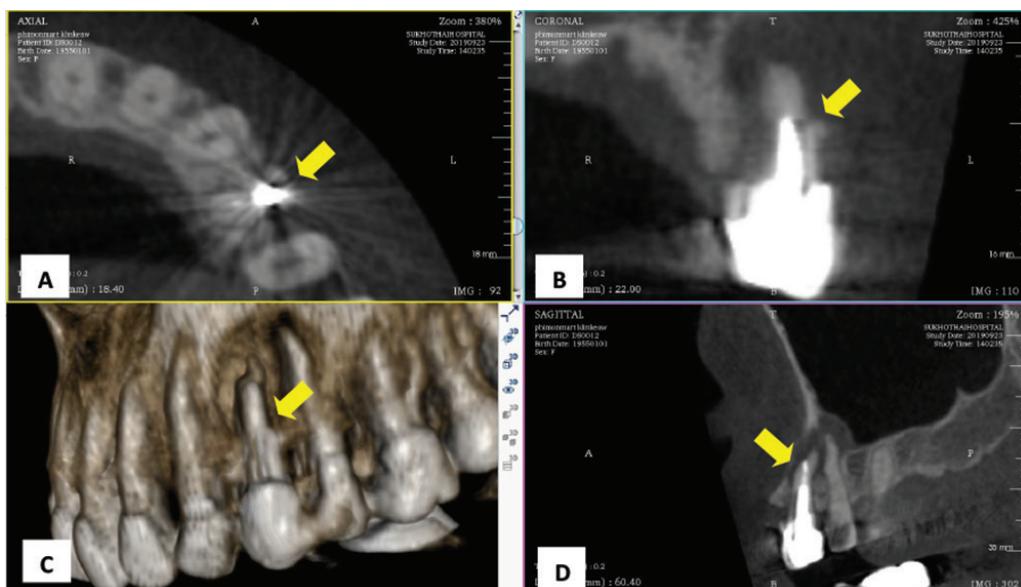
**Figure 1:** CBCT of case 1. CBCT of case 1. (A) axial view, (B) coronal view, (C) reconstruction view and (D) sagittal view.

**Case 1** Axial view: The image shows the artifact of metal post in the root canal, however, the separation of buccal root can be detected.

Coronal view: The image shows clearly separated buccal root from the metal post in the canal.

Sagittal view: The image indicates the bone resorption around the root, the space between buccal root can be detected.

3D image shows the bony destruction around the root of both premolars, the fracture piece of the buccal root can be seen. (Figure 1)

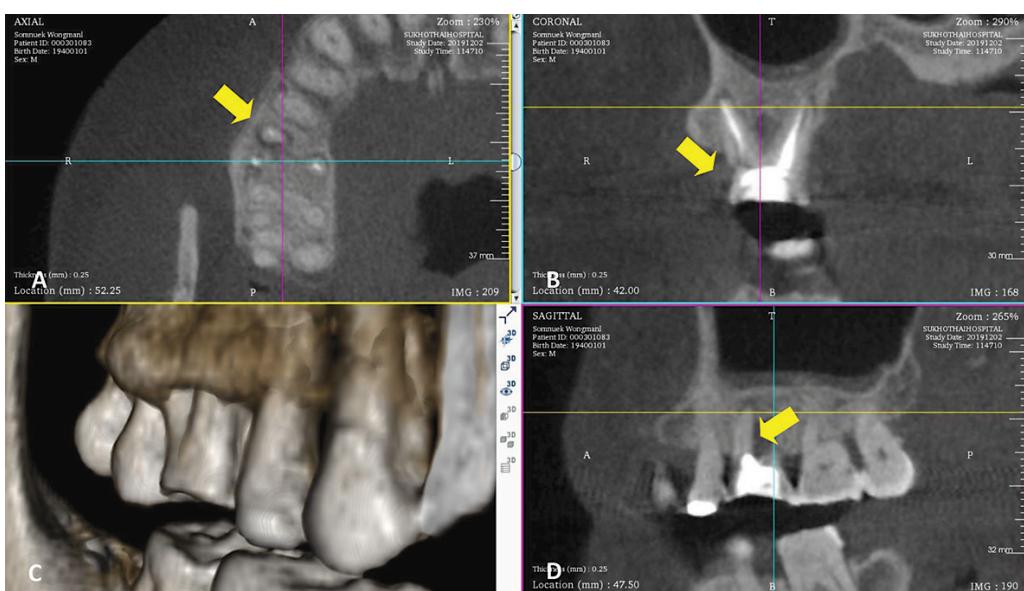
**Figure 2:** CBCT of case 2. (A) axial view, (B) coronal view, (C) reconstruction view and (D) sagittal view.

**Case 2** Axial view: The fracture root cannot be detected. The periapical radiolucency can be detected.

Coronal view: The fracture part of the distobuccal root can be detected.

Sagittal view: The fracture root cannot be seen, however, the bony lesion can be seen more invasion into the furcation.

3D image: The fracture root cannot be detected. (Figure 2)

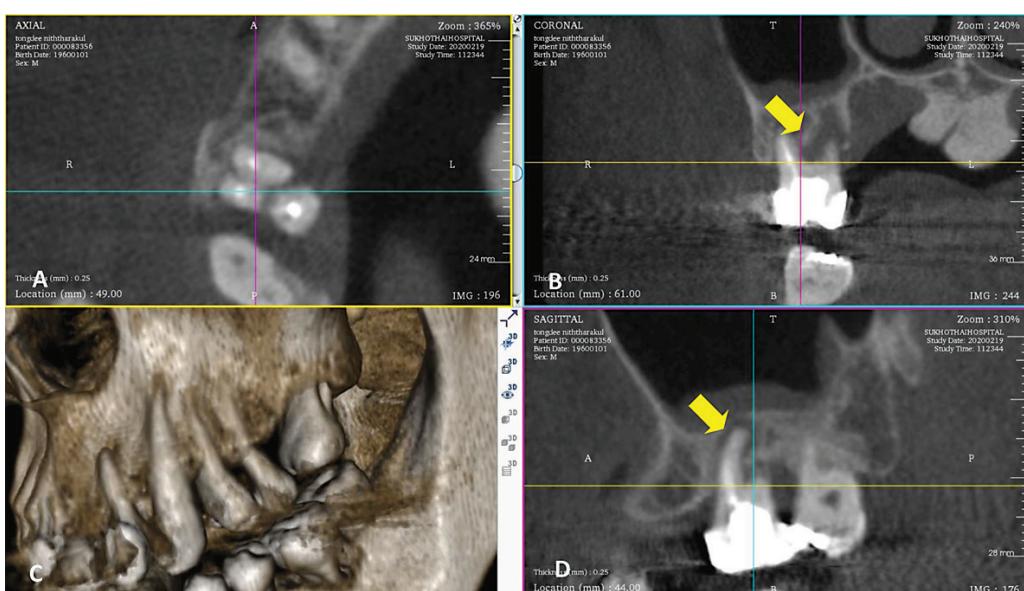
**Figure 3:** CBCT of case 3. (A) axial view, (B) coronal view, (C) reconstruction view and (D) sagittal view.

**Case 3** Axial view: The fracture root cannot be detected.

Coronal view: The fracture root cannot be detected, but the bony lesion around palatal root and buccal can be seen involved in the furcation area.

Sagittal view: The fracture root cannot be detected. Radiolucency (halo lesion) around buccal root can be seen clearly.

3D image: The fracture root cannot be detected. (Figure 3)

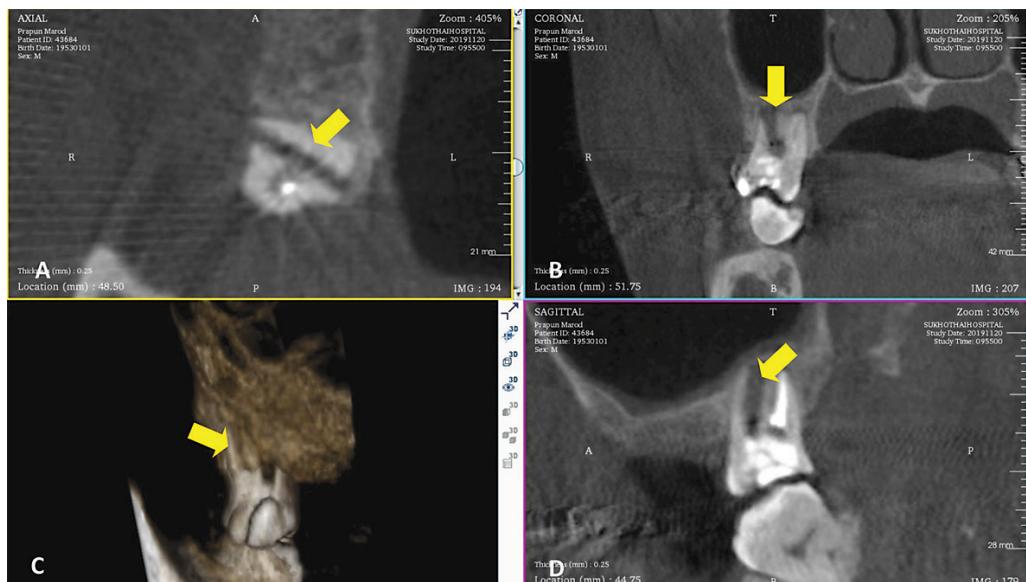
Figure 4: CBCT of case 4. (A) axial view, (B) coronal view, (C) reconstruction view and (D) sagittal view.

**Case 4** Axial view: The fracture part can be clearly detected; the fracture line is seen.

Coronal view: The fracture root which is separated from the buccal root can be found, bony lesion around the root can be seen.

Sagittal view: The fracture line can be detected, the bone resorption around the fracture root is easily seen.

3D image: The fracture root can be seen in the image. (Figure 4)

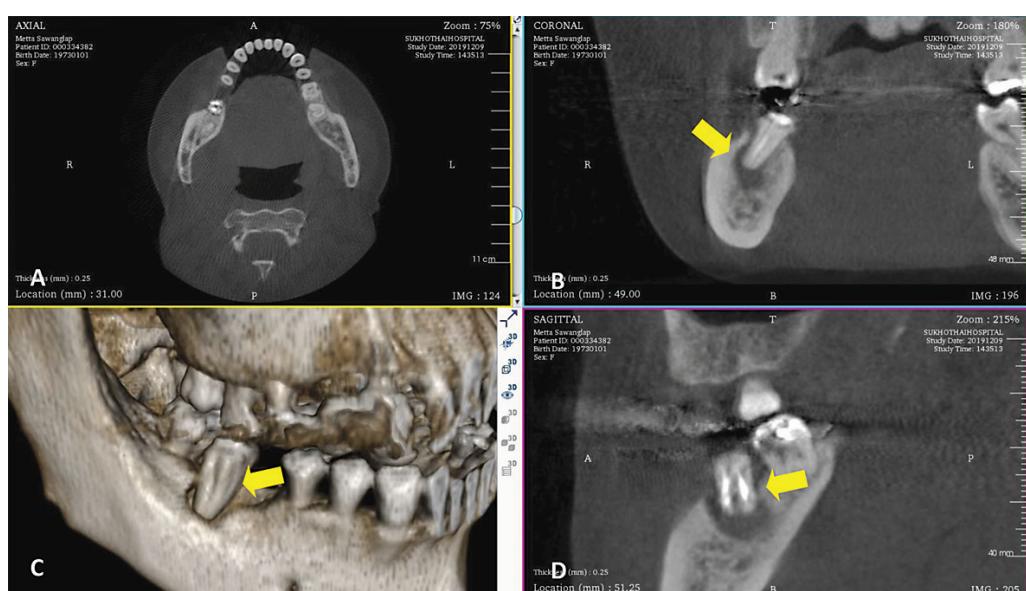
Figure 5: CBCT of case 5. (A) axial view, (B) coronal view, (C) reconstruction view and (D) sagittal view.

**Case 5** Axial view, coronal view, sagittal view, and

3D image: The fracture cannot be detected, however, the bone lesion around the roots in all views is easily seen for the location of the lesion which is reflected the classical finding of root fracture. (Figure 5)

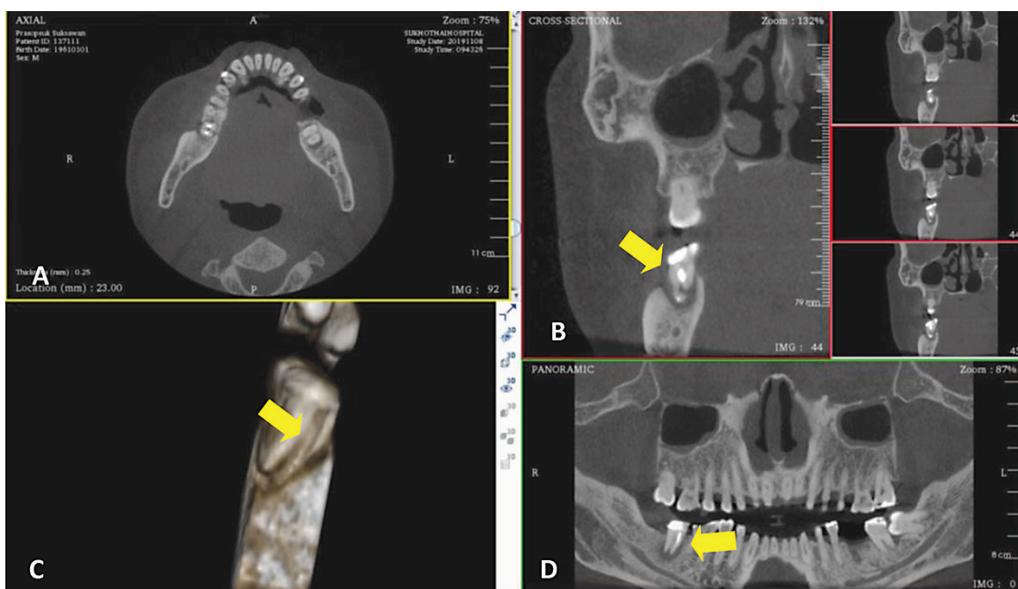
Figure 6: CBCT of case 6. (A) axial view, (B) coronal view, (C) reconstruction view and (D) sagittal view.

**Case 6** The findings of CBCT in axial view, coronal view, and sagittal view are like case 5. However, the fracture root can be detected in 3D image. (Figure 6)

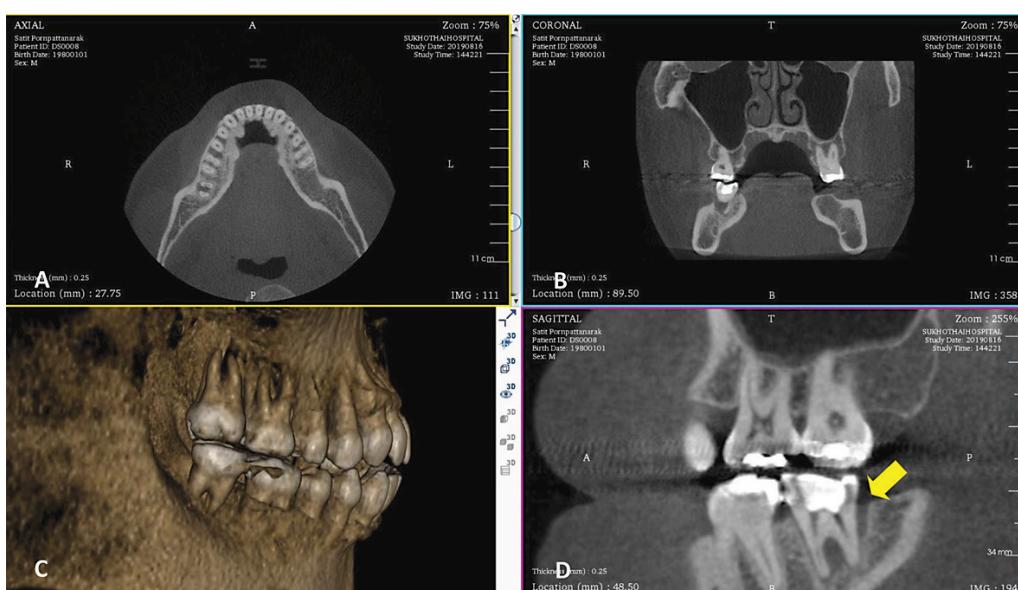
Figure 7: CBCT of case 7. (A) axial view, (B) coronal view, (C) reconstruction view and (D) sagittal view.

**Case 7** CBCT was made before the root canal treatment. For all views of the CBCT image, the fracture root cannot be detected. The radiolucency of bony lesions shows the furcation involvement area better than periapical radiography. The diagnosis of VRF could be made from this finding. (Figure 7)

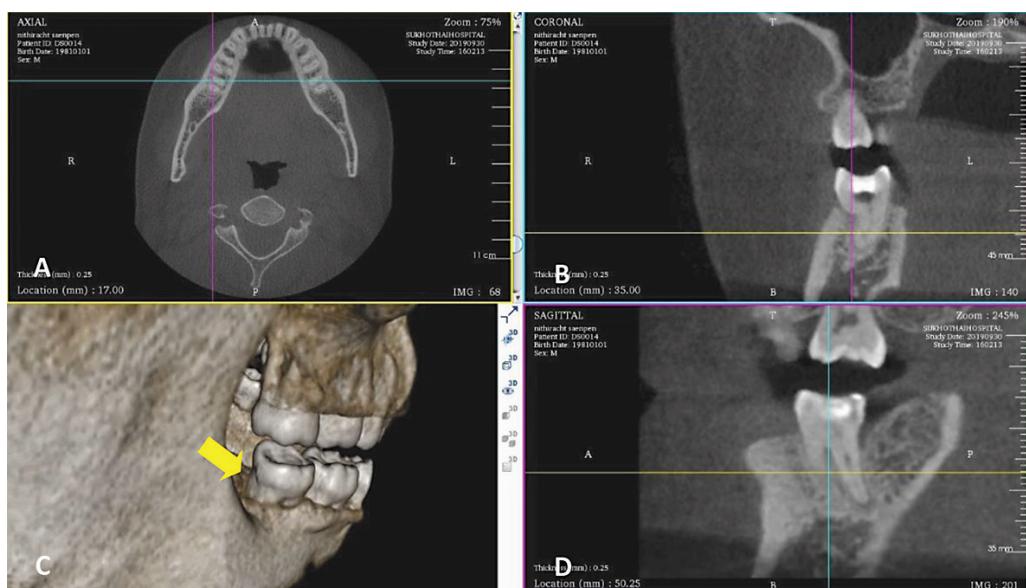
**Figure 8:** CBCT of case 8. (A) axial view, (B) coronal view, (C) reconstruction view and (D) sagittal view.

**Case 8** CBCT was made before the root canal treatment. For all views of the CBCT image, the fracture root cannot be detected. The periapical lesion can be found, but the diagnosis of VRF cannot be made. (Figure 8)

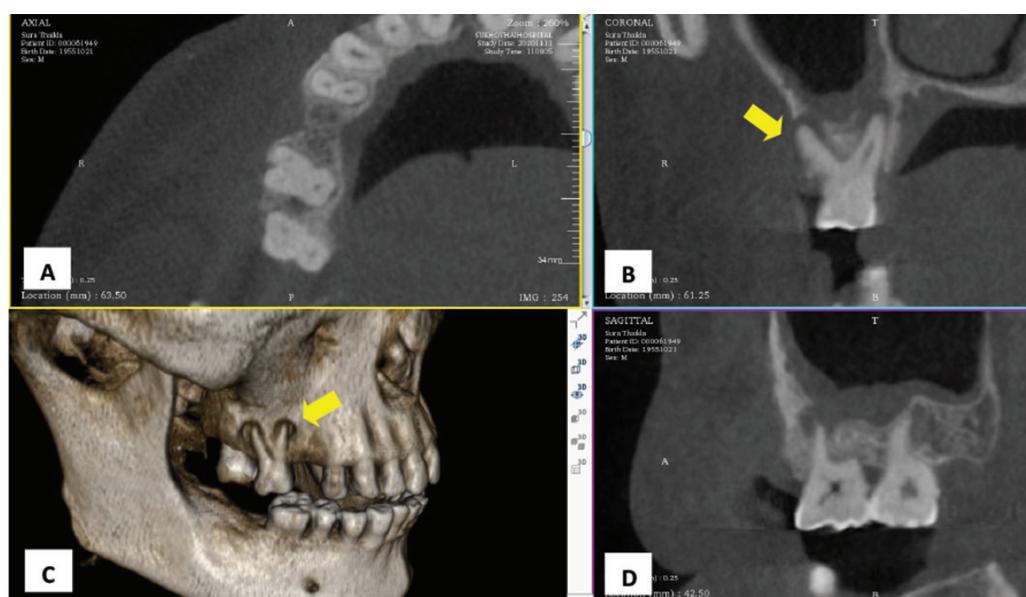
**Figure 9:** CBCT of case 9. (A) axial view, (B) coronal view, (C) reconstruction view and (D) sagittal view.

**Case 9** In all views of CBCT image, the fracture root cannot be detected. But the radiolucency around the tooth and bony pocket especially in 3D image, together with the clinical findings, the diagnosis of VRF can be made. (Figure 9)
