## What is Your Diagnosis?

Ninlawan Thammasiri Nan Choisunirachon

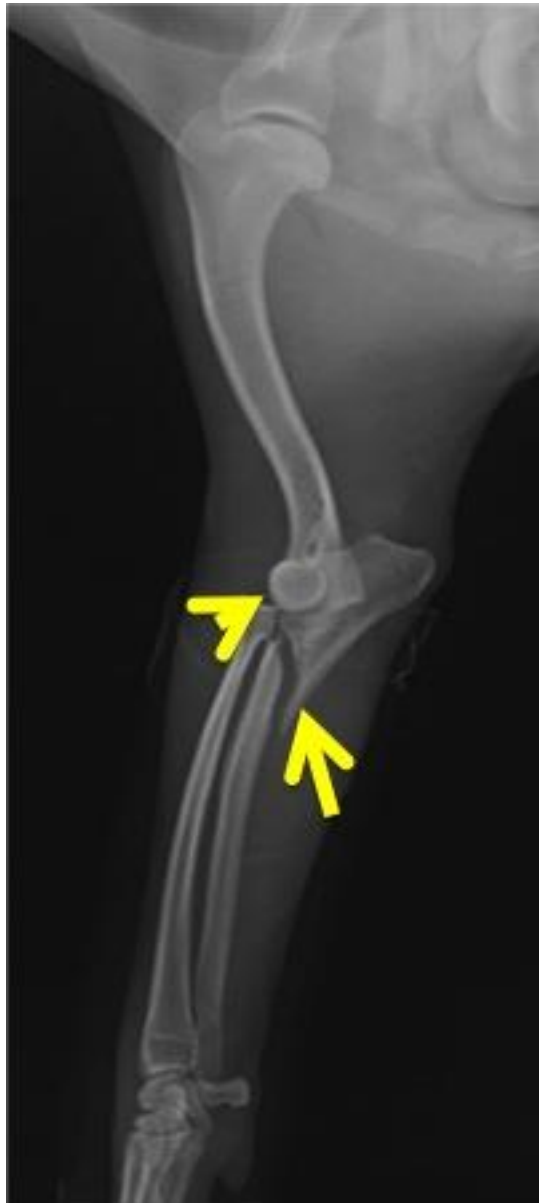
**Figure 1** The lateral projection of the left elbow showed that the radial head was cranially dislocated from the humeroradial joint (arrow head). In addition, there was evidence of the oblique fracture of the proximal third ulna (arrow).

third of left ulna with cranial dislocation of the radial head concurrence with adjacent soft tissue swelling that more distinctively on the lateral projection (Figure. 1) than that of the anteroposterior projection (Figure 2).

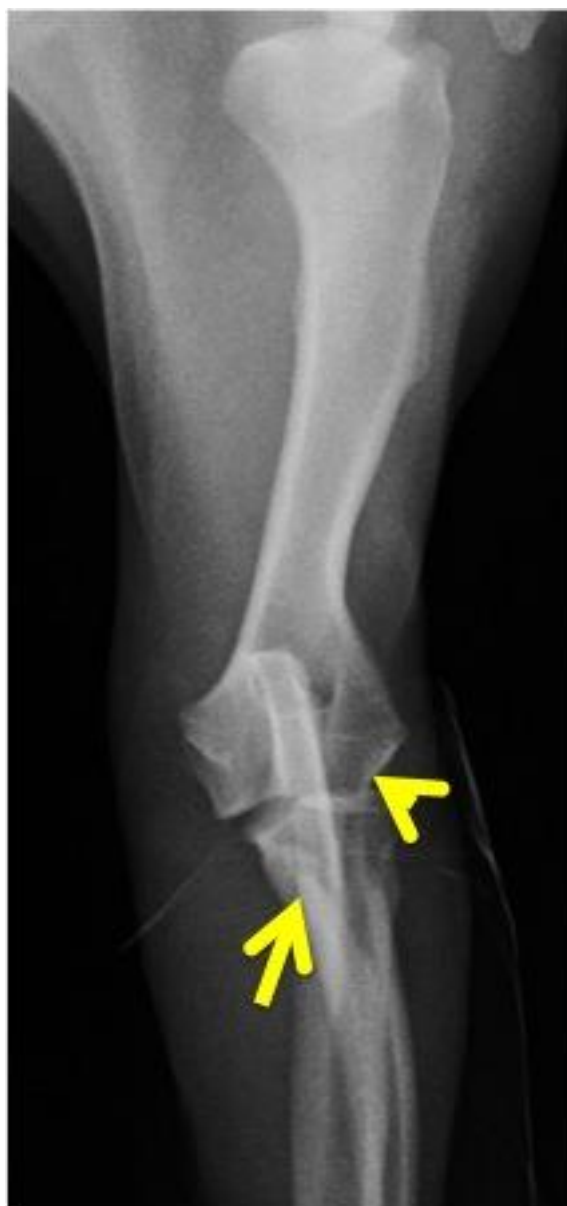
**Figure 2** The anteroposterior projection of the elbow joint, the incongruity of the humeroradial joint was detected (arrow head). Besides, the superimposition of the fracture line at the ulna was seen (arrow).
