Ultrasound Diagnosis

Phiwipha Kamonrat

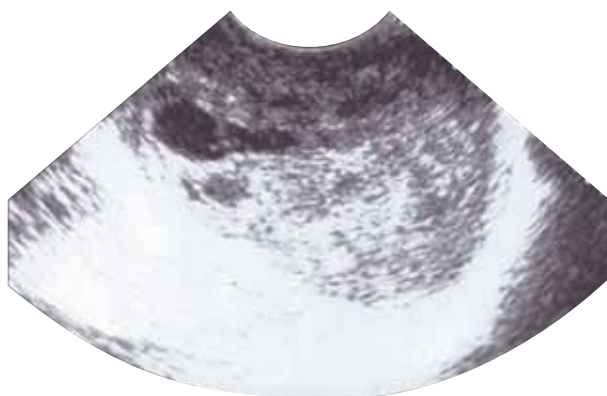
Figure 1 A sagittal ultrasonographic image of the right thigh mass of a 13-year-old, spayed female, Thai ridgeback dog in lateral recumbency. A 3.3 x 4.7 cm, well-defined, heterogeneous structure, was found to be localized within the subcutaneous tissue and did not invade the underlining muscle.

Ultrasonography was performed, using a real-time scanner with an 8-5 MHz broadband, convex, phased array transducer. Scans of the lesion revealed a 3.3 x 4.7 cm heterogeneous structure, localized within the subcutaneous tissue (Figs. 1, 2). This structure was well-defined, containing some anechoic cavitation of fluid and diffuse areas of patchy hyperechogenicity. It did not invade the underlining muscle. An ultrasonographic evaluation of the abdomen demonstrated a homogeneous, hyperechoic, hepatic parenchyma, relating to a kidney. There was no evidence of a hepatic nodule. Other abdominal organs were within normal limits.

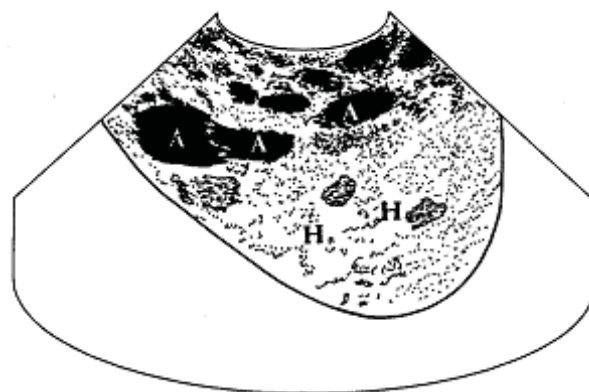
Figure 2 Schematics of the relative positions of the structures scanned in Fig. 1. A-anechoic component of tumor; H-hyperechoic component of tumor.
